**Facilities Study for the City of Windsor Heights**  
**Public Works Maintenance Garage and Salt Storage Shed**

Project: #18037 Windsor Heights Public Works Facilities Assessment

July 24, 2018

### **Facilities Study of Public Works Maintenance Garage and Salt Storage Shed.**

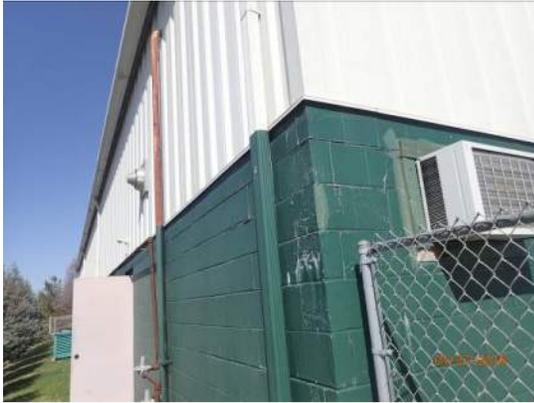
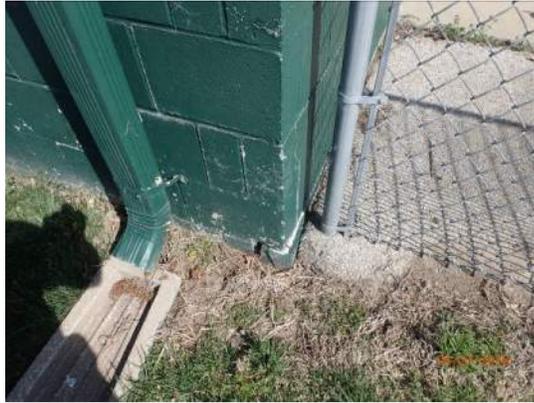
5, 6. Views of block distress

The concern with the building is that the salt has deteriorated the concrete block, the concrete floors and the metal in some portions of the buildings. The salt storage shed has severe deterioration, the maintenance building has many areas of deterioration.

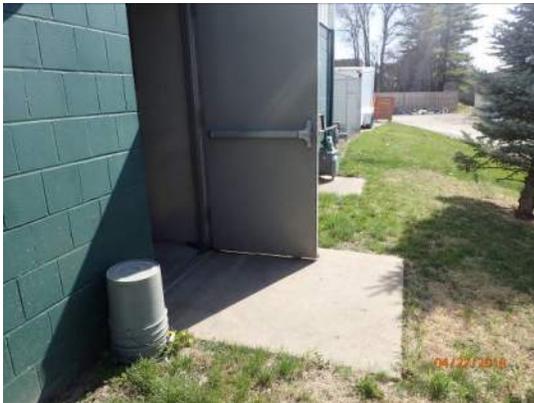
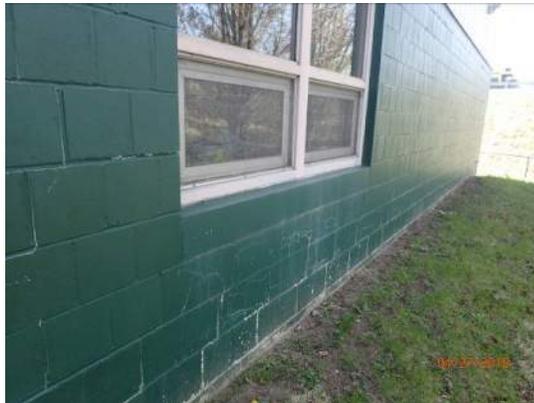
7, 8. Views of block distress

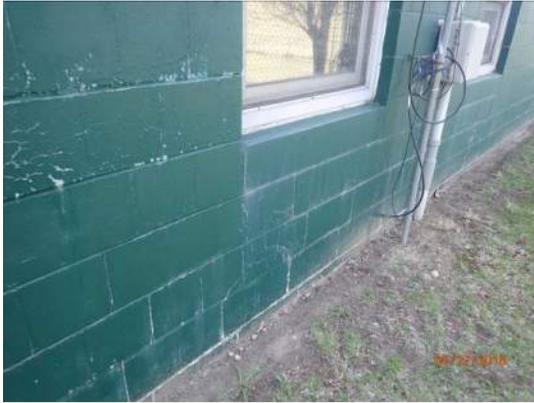
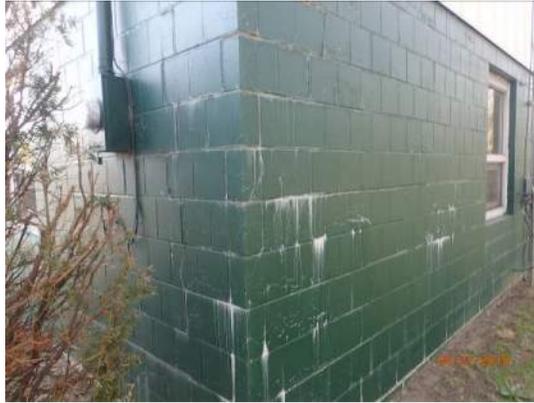
9, 10. Views of efflorescence

The maintenance building has numerous areas of concern. Most of them are related to deterioration due to salt. The first is the concrete block. There is efflorescence (salts leaching through the block) in many areas. The potential concern is that the salts are also rusting the reinforcing steel inside of the block. There is "crazing" (numerous hairline fractures) of the block. At this point it does not appear that the block is failing, but the slow deterioration will eventually lead to more severe problems. The block could be cleaned and sealed to extend its life.

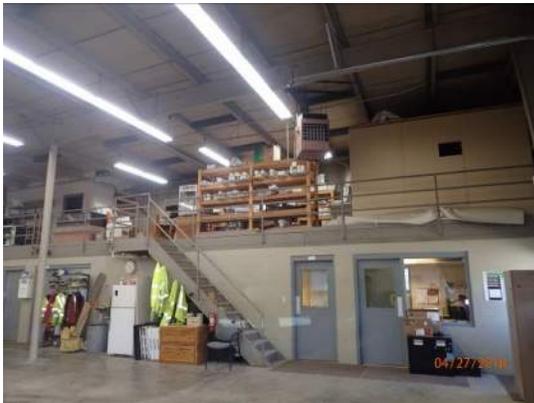
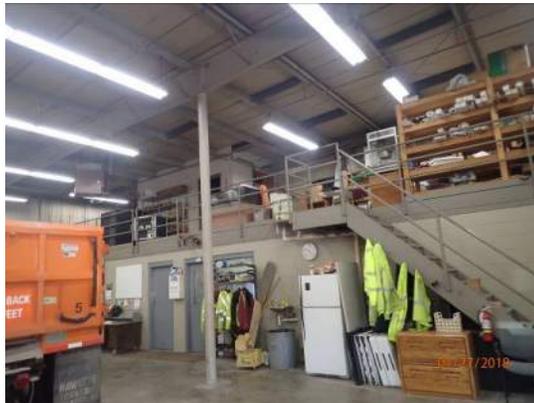
11, 12. Views of interior mezzanine

The wood framed mezzanines appear to be in good condition. The mezzanines did not appear to be load rated as required by OSHA, but the drawings indicate they have a 125#/sf capacity. The landing of the stair did not appear to have a 4" toe kick.

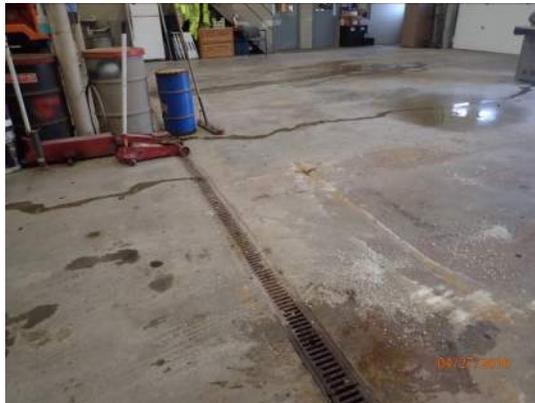
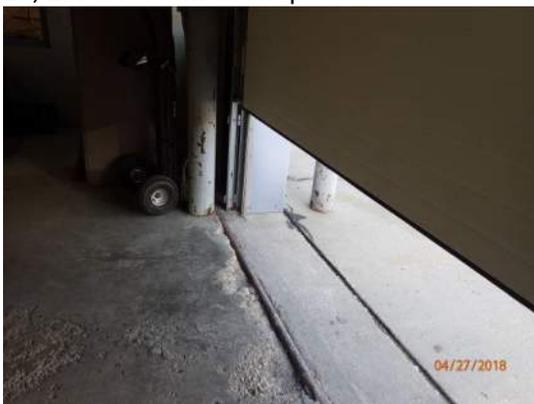
19, 20. View of concrete in need of repair

The floor of the building is in poor condition. The salts have eaten the surface of the concrete. There are many areas where the pitting of the concrete is present, especially at the overhead doors. The floors do slope to the middle and there is a trench drain that collects the salt-laden water. There are significant cracks radiating from these locations. An epoxy topping could be added to the floor or the floor could be removed and replaced.

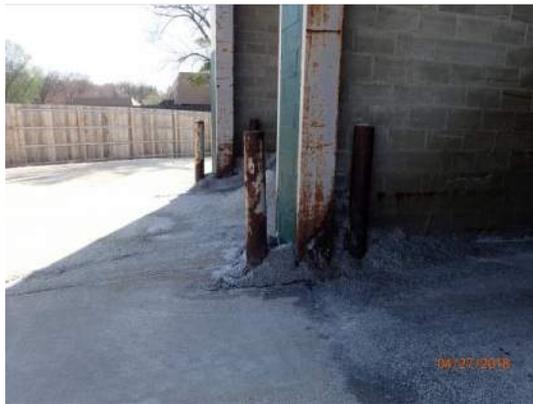
25, 26. Views of masonry distress

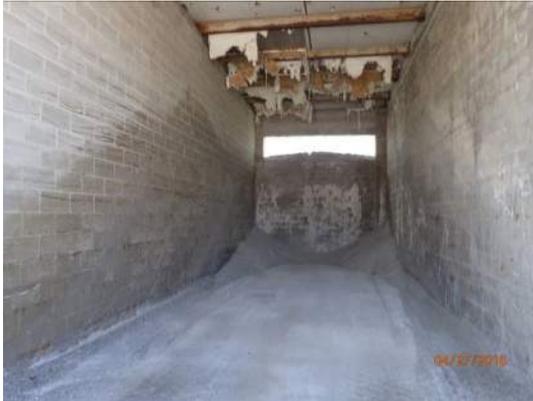
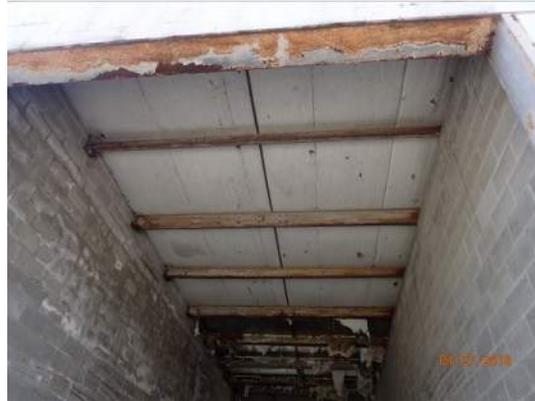
27, 28. Interior views of masonry distress and steel rusting

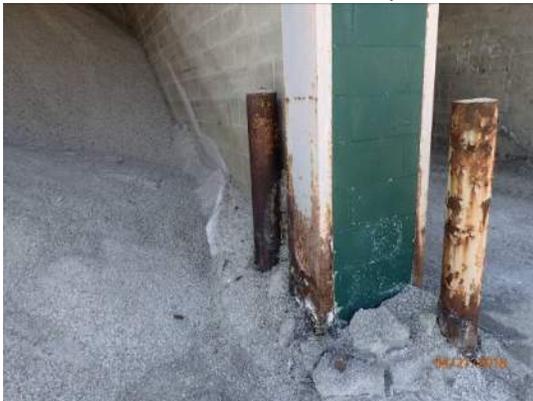
29. View of damage at base

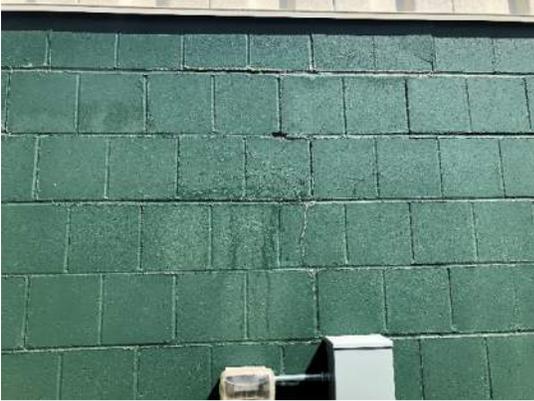
South elevation missing mortar

to be laid in cold conditions. The block itself also has salts present in the cement used to make the block. If water finds its way to the salts, the wall will experience efflorescence, which is water acting as a vehicle to carry the salts out of the block. This is then expressed as a white powder or haze on the face of the masonry materials. If water is present in the walls, several types of damage can occur and shorten the life of the building. The west walls especially are showing signs of water damage on the exterior of the building with failing mortar, cracks, efflorescence, rusted metal (window frames, lintels). The failed mortar joints will require tuck-pointing.

1. Flashing needs to be removed and new flashing installed.
2. Insulation behind the panels needs to be increased to meet code.
3. Efflorescence needs to be removed, treated and the walls repainted.
4. Replace rusted doors and windows

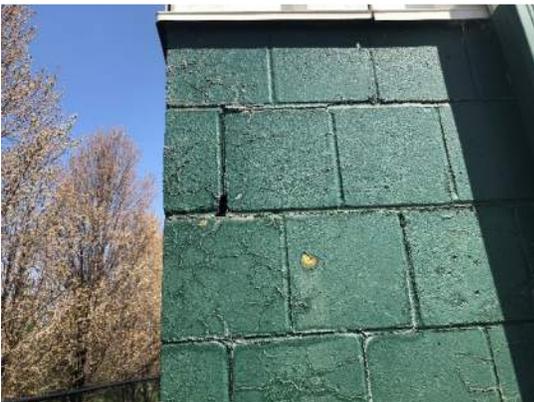
SW corner missing mortar

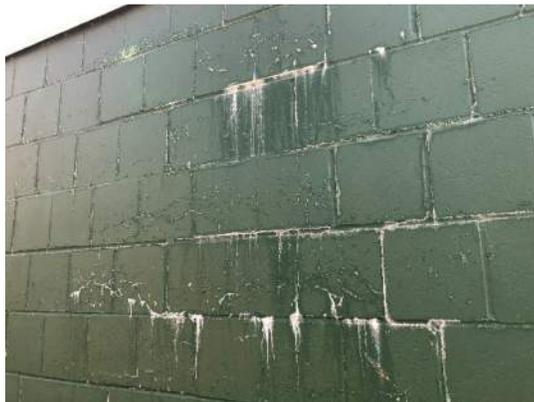
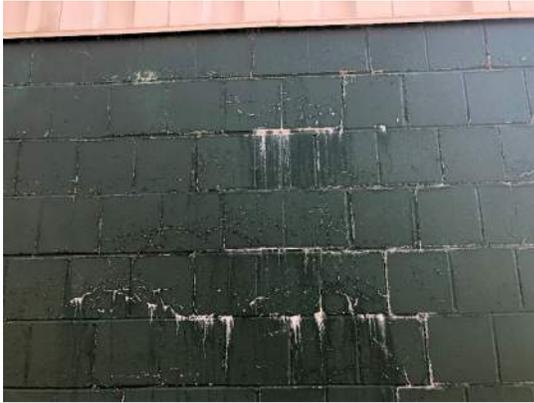
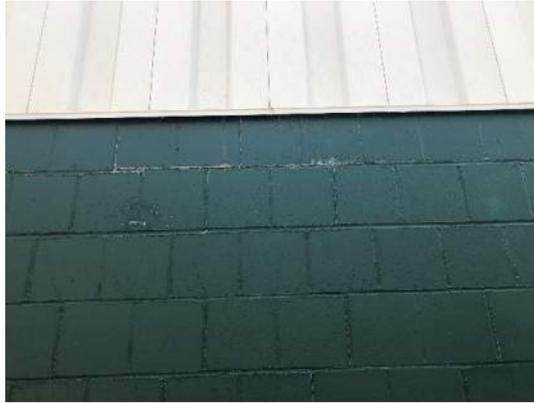
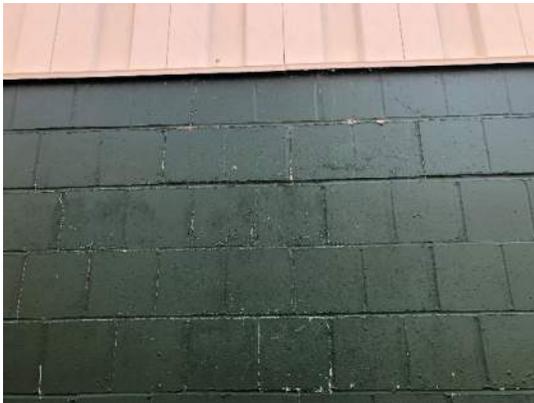
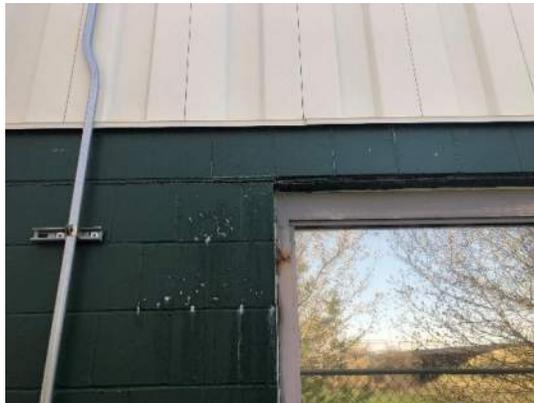
West elevation efflorescence

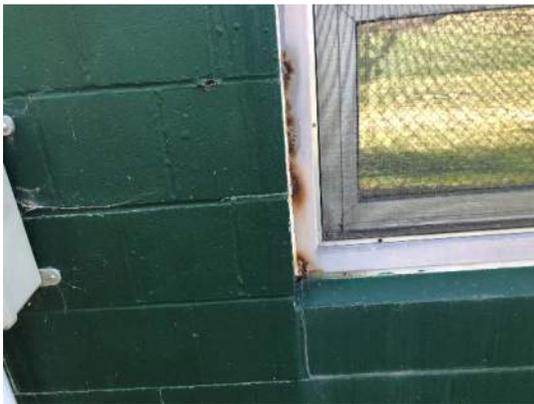
West elevation rusted frame

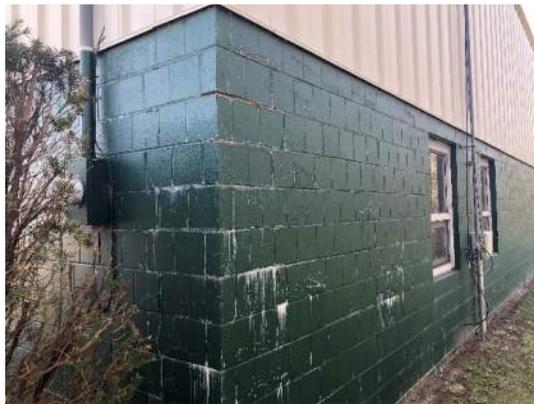
NW corner efflorescence and missing mortar

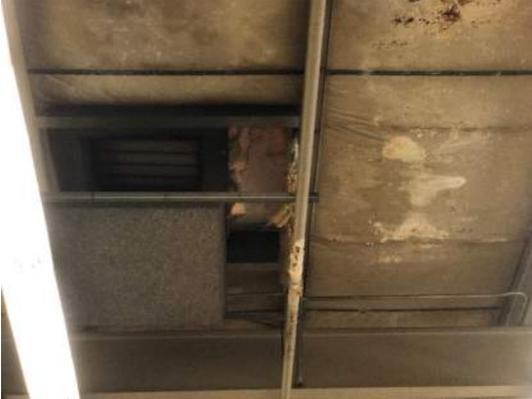
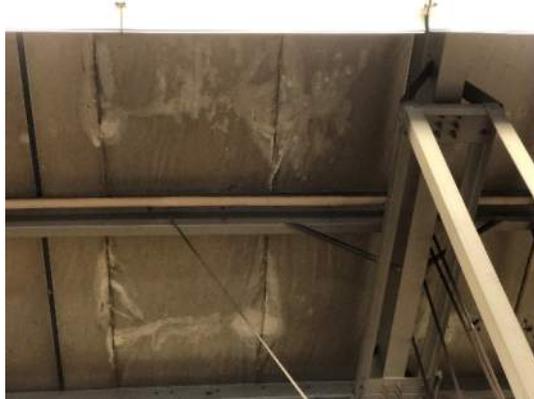
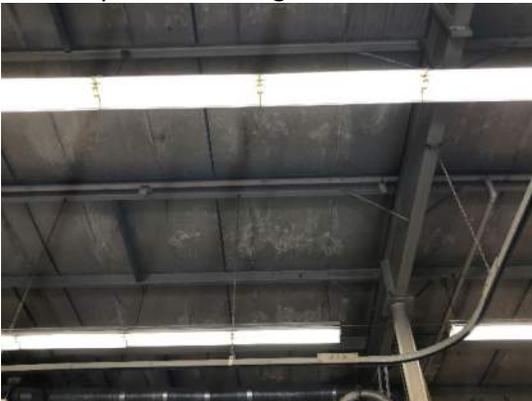
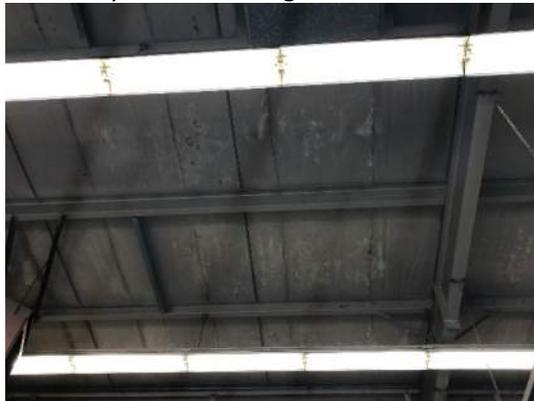
West bays water damage

The interior ceilings consist of exposed Kraft-faced insulation and painted steel beams and purlins. This is a very typical finish for a utility building. Several areas of the ceiling insulation and structure have signs of water infiltration and damage. Some areas are much worse than others, but much of the insulation is damaged beyond the ability to just paint over it. If it is decided to add the flute-fill TPO roof system mentioned earlier, the insulation inside of the building could be removed and the metal panels above could be painted white. New white paint on the ceilings will spread light around the building better and reduce the number of fixtures needed.

1. After roof leaks are addressed, upgrade and paint underside of roof.

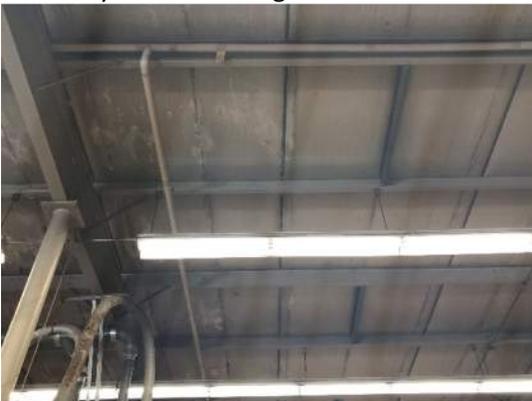
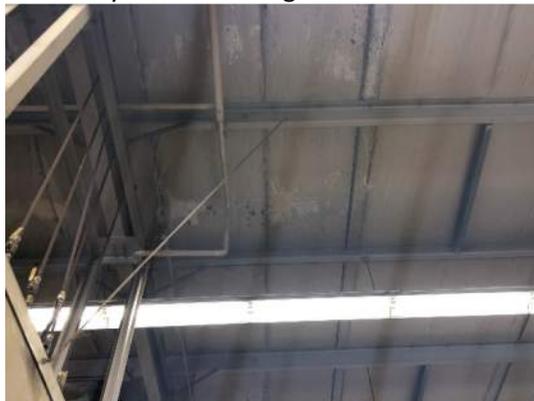
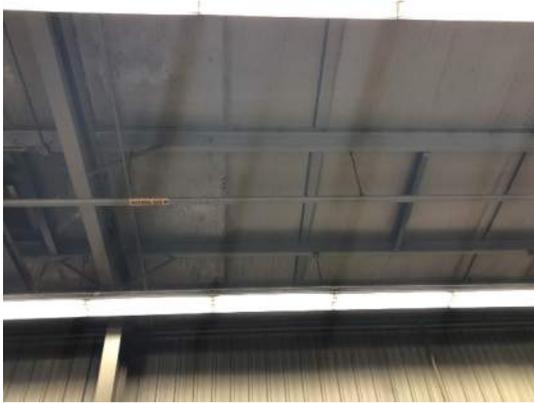
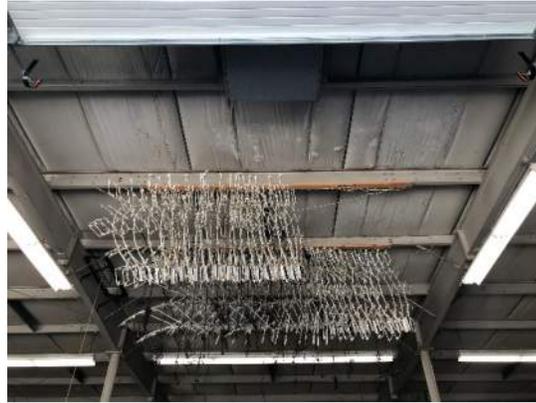
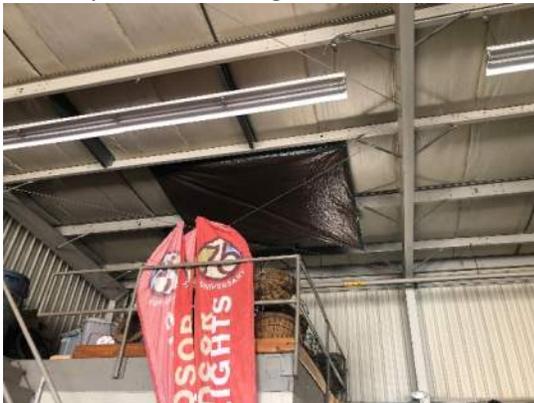
East bay's water damage

East bays water damage

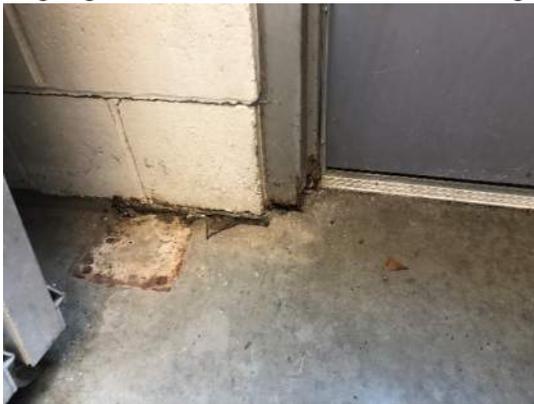
Rusted frame in dog cage room

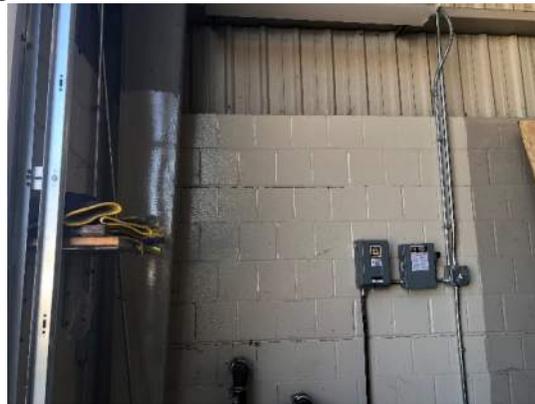
Wall cracks at SE corner

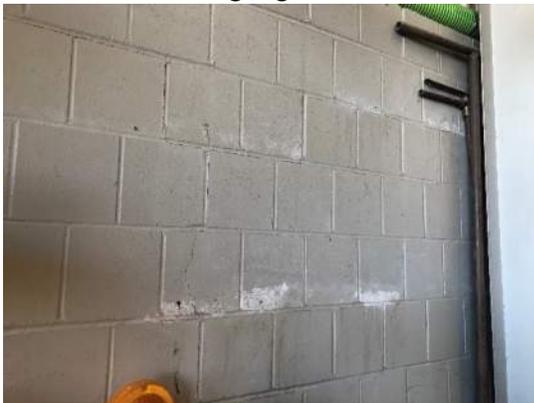
East wall efflorescence

The interior walls are painted concrete block for the most part (mezzanine has a few framed walls). Overall the condition of the concrete block walls is good. Almost all the exterior walls have efflorescence present that has caused the paint to discolor and fail. It is hoped that addressing the flashing issues on the building exterior will eliminate the water infiltration and end the efflorescence inside the building. The walls will need to be cleaned with a weak acid solution and wire brush. Once the area is cleaned, rinsed and dried, new primer and paint can be applied. If the water infiltration issue is properly addressed on the building exterior, the efflorescence should not return.

1. Clean efflorescence off walls and paint.
2. Insulation behind the panels needs to be increased to meet code.

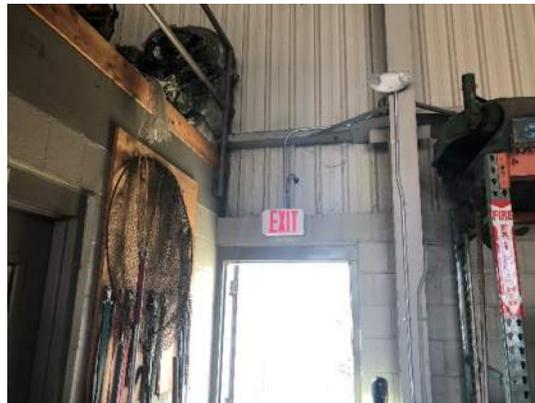
South wall efflorescence

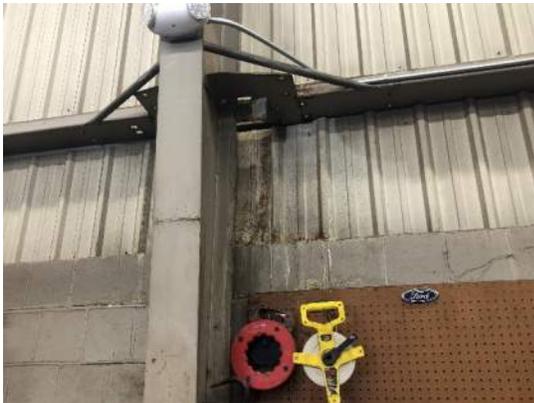
South wall efflorescence and water damage

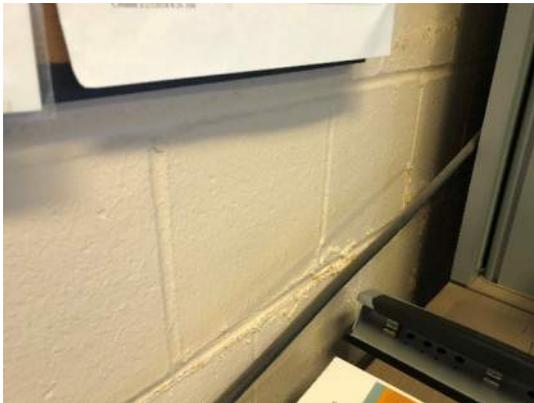
Efflorescence on West office wall

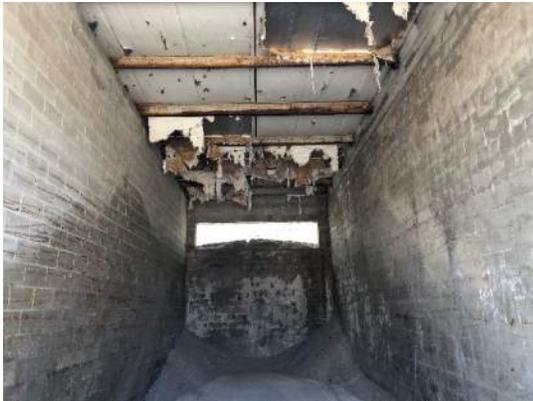
Salt building distressed materials

The roof is a single slope metal roof that drains from north to south. The original screw down metal roof is still in place and is experiencing leaks at several locations. The original batt insulation is also in place and shows signs of water damage in more than half of its area. Several of the roof penetrations and curbs

1. New roof required.
2. New structure for roof that won't rust should be considered.
3. Insulation is not required.
4. Replace gutters and downspouts.
5. Replacement of building makes most sense - safety.

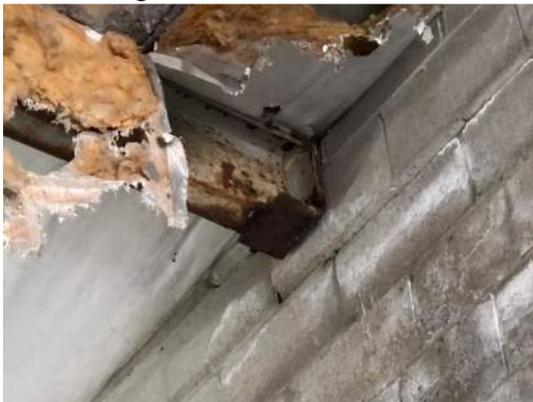
Salt building distressed steel supports

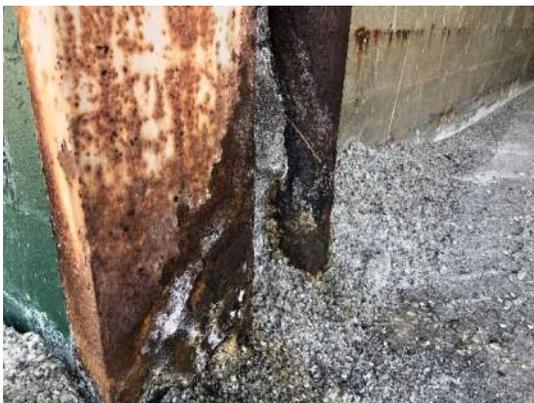
Rusted opening steel

delivered to the building and when salt is removed with heavy equipment. The steel plate and bollards at the front openings are rusted badly.

1. Building is extensively damaged and should be considered for replacement.

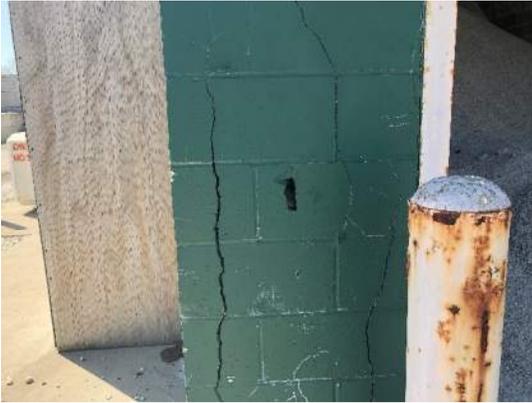
Cracks in all corners

The exterior walls consist of painted concrete block. The concrete block has several areas that are experiencing efflorescence and major cracks. This building is subject to great lateral forces when salt is

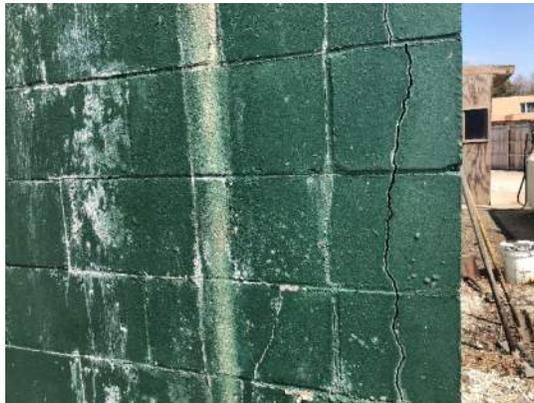
Cracks in all corners

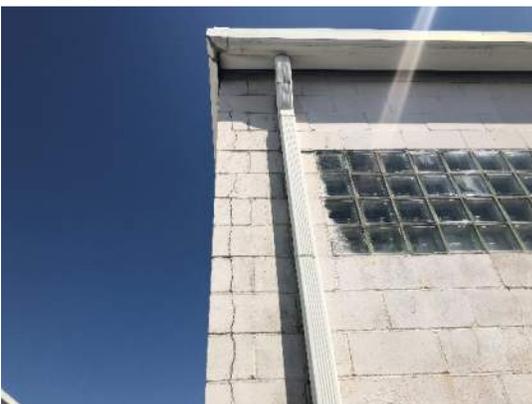
Cracks in all corners
