**Facilities Study for the City of Windsor Heights**  
**Public Works Maintenance Garage and Salt Storage Shed**

Project: #18037 Windsor Heights Public Works Facilities Assessment

July 24, 2018

### **Facilities Study of Public Works Maintenance Garage and Salt Storage Shed.**

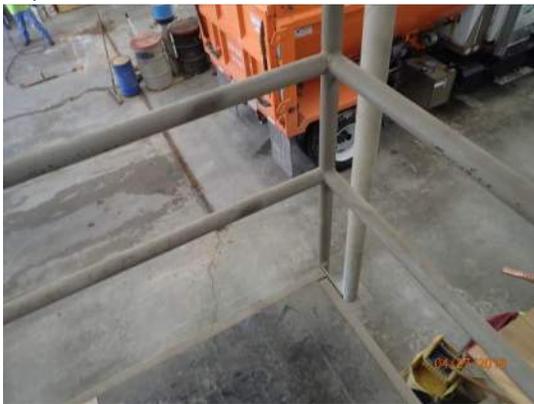
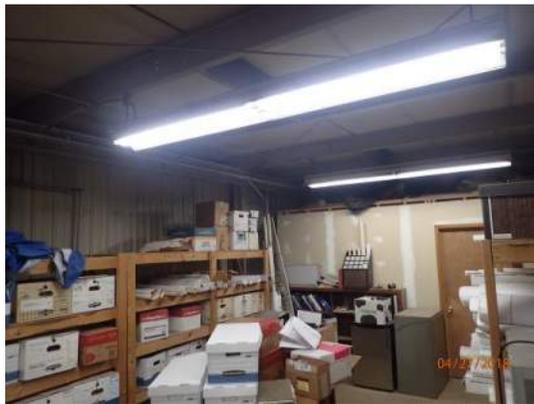
13, 14. Views of mezzanine

The wood framed mezzanines appear to be in good condition. The mezzanines did not appear to be load rated as required by OSHA, but the drawings indicate they have a 125#/sf capacity. The landing of the stair did not appear to have a 4" toe kick.

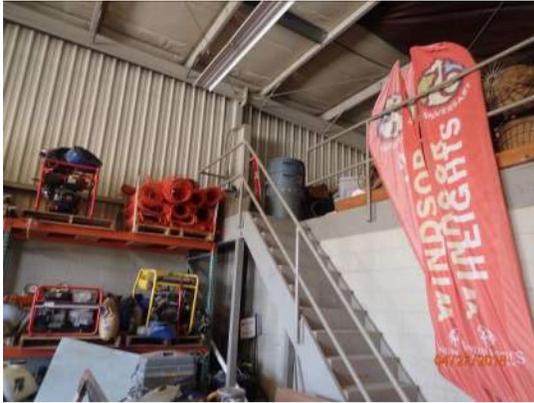
15, 16. View of second mezzanine

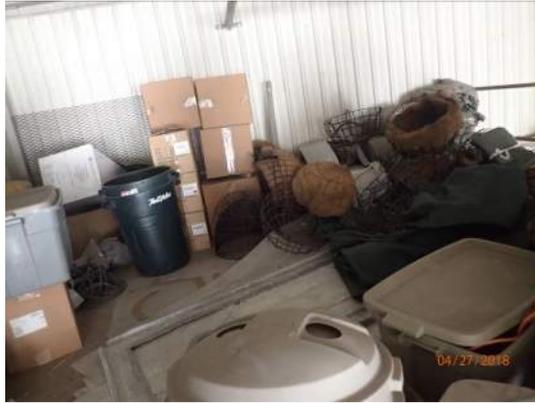
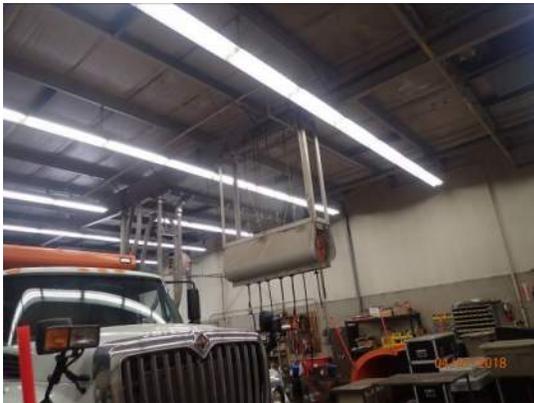
17, 18. Overview of shop

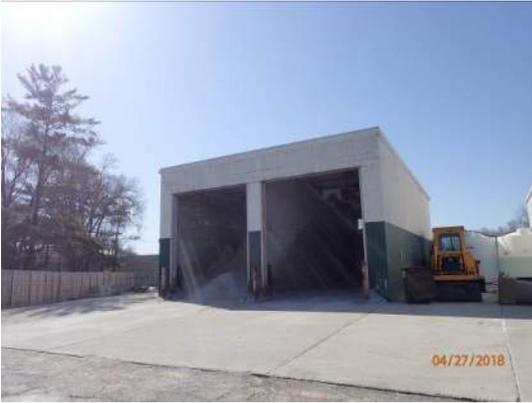
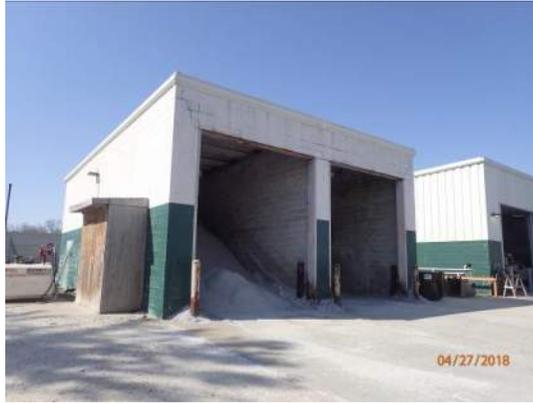
21, 22. Views of salt storage building

In general, the maintenance building needs some improvements but can be economically salvaged. The salt storage building has significant deterioration in many areas. The roof framing has been compromised by rusting of the steel framing members. The roof will continue to rust and will eventually be close to collapse. The sidewalls also have significant signs of deterioration, especially on the north side. There are many cracks in the masonry block. The block will continue to deteriorate as it continues to be exposed to salt and weather. The building will most likely be more expensive to repair than to replace.

1. The maintenance building needs some improvements but is economically salvageable.
2. The salt storage building should be demolished and replaced.

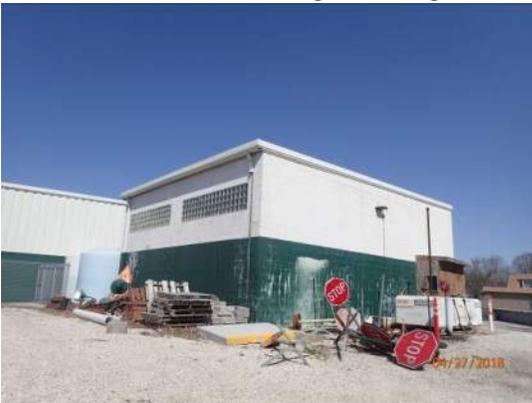
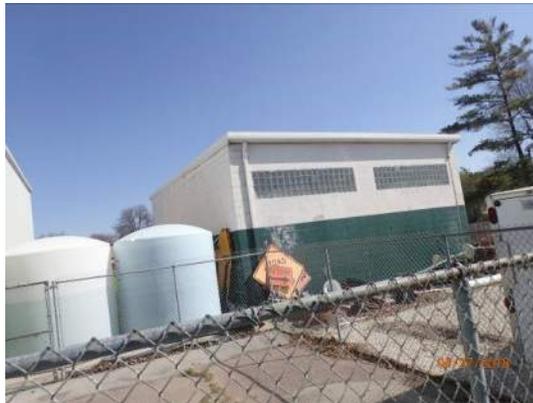
23, 24. Views of salt storage building

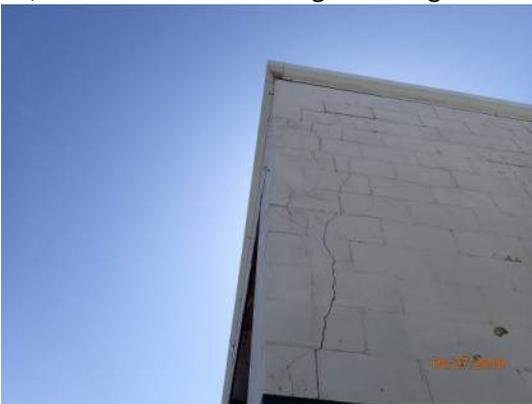
25, 26. Views of masonry distress

The maintenance building has numerous areas of concern. Most of them are related to deterioration due to salt. The first is the concrete block. There is efflorescence (salts leaching through the block) in many areas. The potential concern is that the salts are also rusting the reinforcing steel inside of the block. There is "crazing" (numerous hairline fractures) of the block. At this point it does not appear that the block is failing, but the slow deterioration will eventually lead to more severe problems. The block could be cleaned and sealed to extend its life.

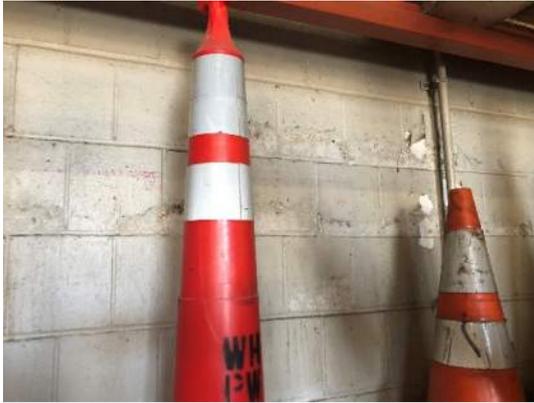
South wall efflorescence

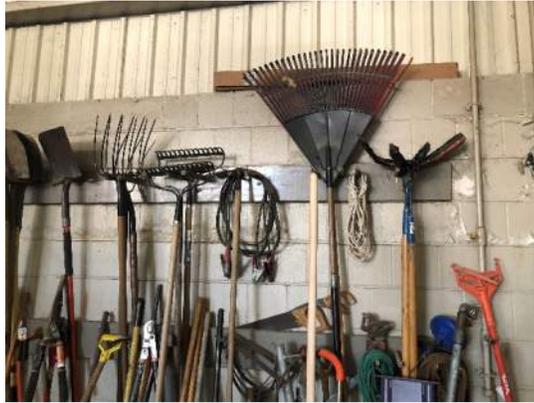
South wall efflorescence

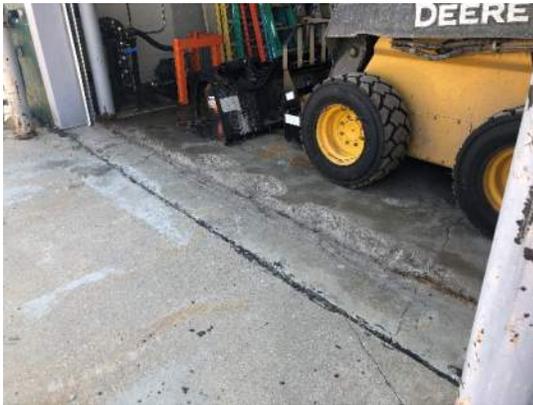
NE corner door

The interior floors are sealed concrete for the most part (mezzanine has framed plywood floors). Overall the condition of the concrete floors is good. There are some areas in the maintenance bays where salt and heavy equipment has caused damage to the floors. At the sill of several of the overhead doors there is spalled concrete and rusted out steel pipe that was cast into the floor slab. The concrete slab near the brine pump is spalled as well as areas where the trucks park. The cast iron trench drain grate has oxidized from the salt but is still in good condition. The bottoms of the interior columns and base plates of the structure show signs of rust that will need to be repaired.

1. Clean/blast floors to remove loose material and paint.

2. Repair/replace trench drain covers.

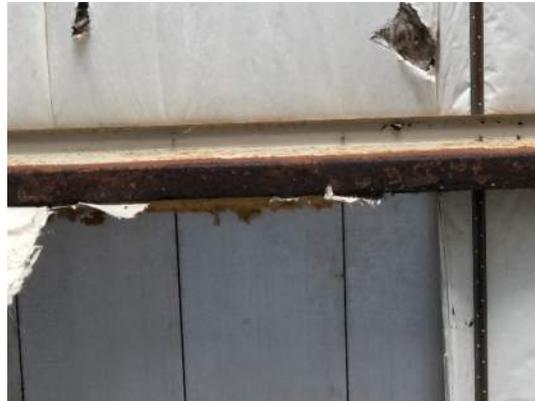
Salt building distressed roof structure

The roof is a single slope metal roof that drains from north to south. The original screw down metal roof is still in place and is experiencing leaks at several locations. The original batt insulation is also in place and shows signs of water damage in more than half of its area. Several of the roof penetrations and curbs

show signs or leaks either active or previously active. The gutters at the back of the building appear to leak at each of the seams. The downspouts appear to be missing and need to be replaced. The downspouts empty out on to splash blocks and the water is surface drained.

1. New roof required.
2. New structure for roof that won't rust should be considered.
3. Insulation is not required.
4. Replace gutters and downspouts.
5. Replacement of building makes most sense - safety.

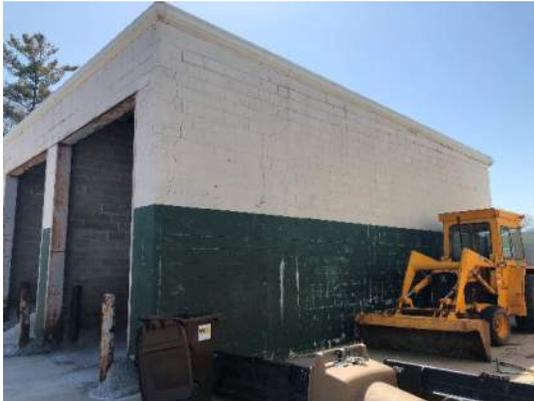
NW corner

The exterior walls consist of painted concrete block. The concrete block has several areas that are experiencing efflorescence and major cracks. This building is subject to great lateral forces when salt is

delivered to the building and when salt is removed with heavy equipment. The steel plate and bollards at the front openings are rusted badly.

1. Building is extensively damaged and should be considered for replacement.
